PROJECT REPRESENTATIVE'S DAILY REPORT

Pg. 1
Report No. 031
Date: 2014-09-30
Day: Tuesday

Project: Renovation and Addition to Tewksbury Town Hall

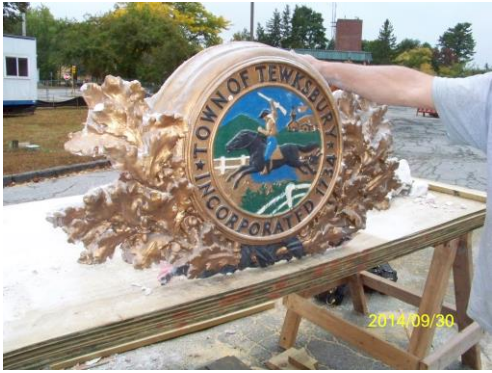
<p>Photo showing carpenters starting to remove the framing so the town seal can be attempted to be removed.</p>
 	<p>Photo showing the back side of the proscenium where the town seal is located. The orange paint spots correlate with the size of the seal on the front side.</p>
 	<p>Photo showing the proscenium with the seal removed.</p>
 	<p>Photo showing the seal removed with the framing. The seal has numerous cracks and is very fragile. Given the construction of the seal, having the mold made for future use was a good decision</p>

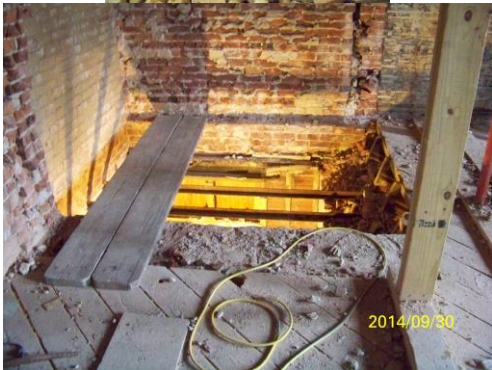
Photo showing fully demolished vault.

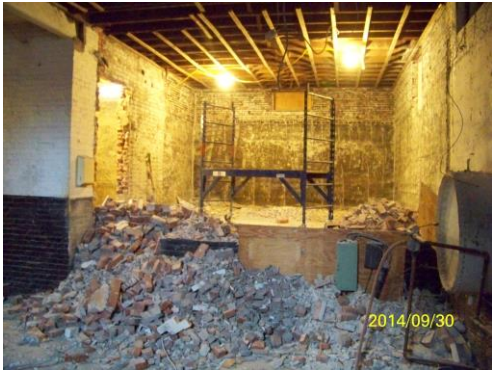
Photo showing demolished wall between the boiler room and the storage room in the basement.
